**REPORT ON THE FIELD WORK BY UWI STUDENTS IN THE MILE GULLY
WARWICK CASTLE AREA
SUMMER 2008
Prepared by Students**

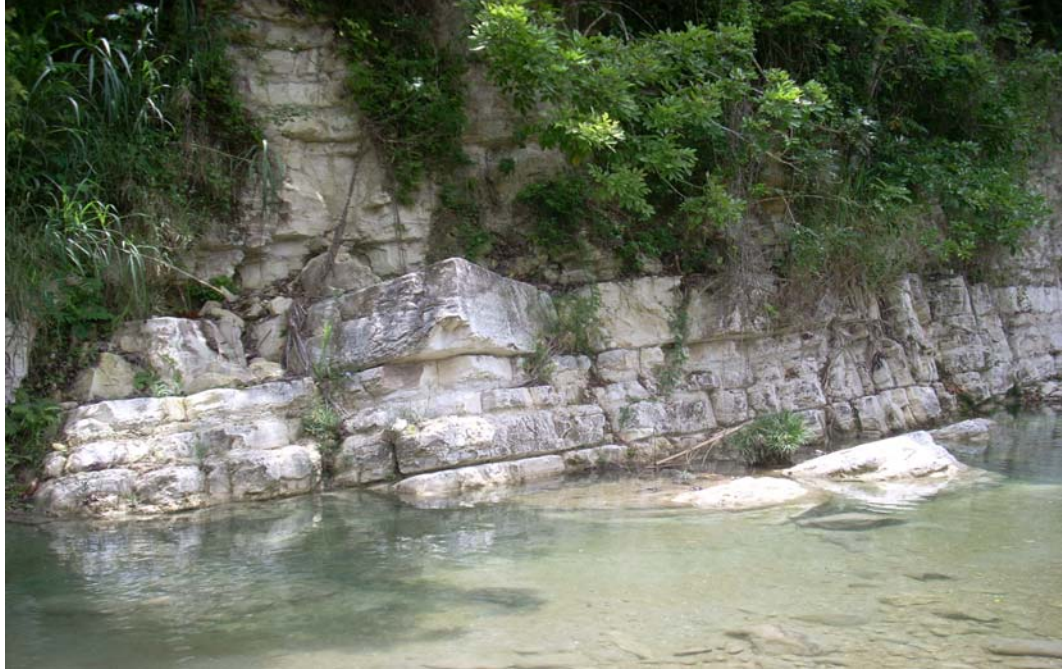
The white limestone seen was basically hard in most areas except where weathered. In most cases the limestone was bedded or jointed with huge blocks falling into the river due to wedge failure. This is shown in picture 1 below.

PICTURE 1 SHOWING BLOCKS OF WHITE LIMESTONE

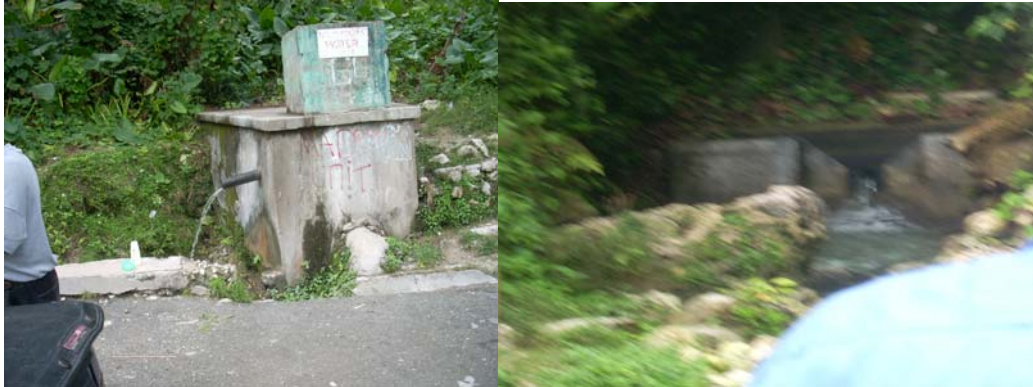
PICTURE 2 AND 3 SHOWING CHAPEL SPRING AND SILVER SPRING
RESPECTIVELY.

These springs maintain an almost constant flow all the year round and never go dry according to residents, which allowed us to infer that the size of the underground aquifer and the surrounding watershed is quite large and groundwater may be flowing from far distances to this area. It should be noted that further up the course of the river much of it is dry as this is the dry season and there are much more larger limestone outcrops seen which are harder, therefore more compacted and more resistant to erosion. However, at about 1.5km down the river, 2-3 springs emerge and the flow of the river is started by these springs. Therefore, it has been these springs that have been keeping the river flowing all through the year and not primarily that of precipitation.

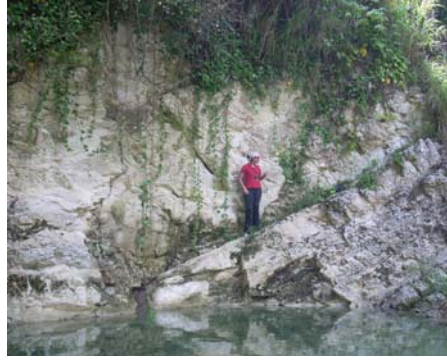
PICTURE 4 SHOWING BEDDING OF LIMESTONE.

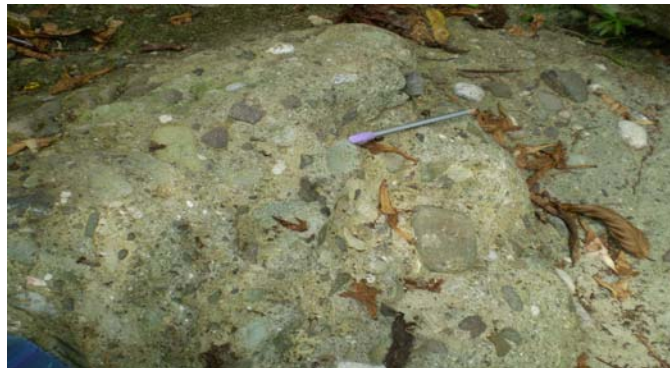
PICTURE 5 SHOWING CONGLOMERATE.

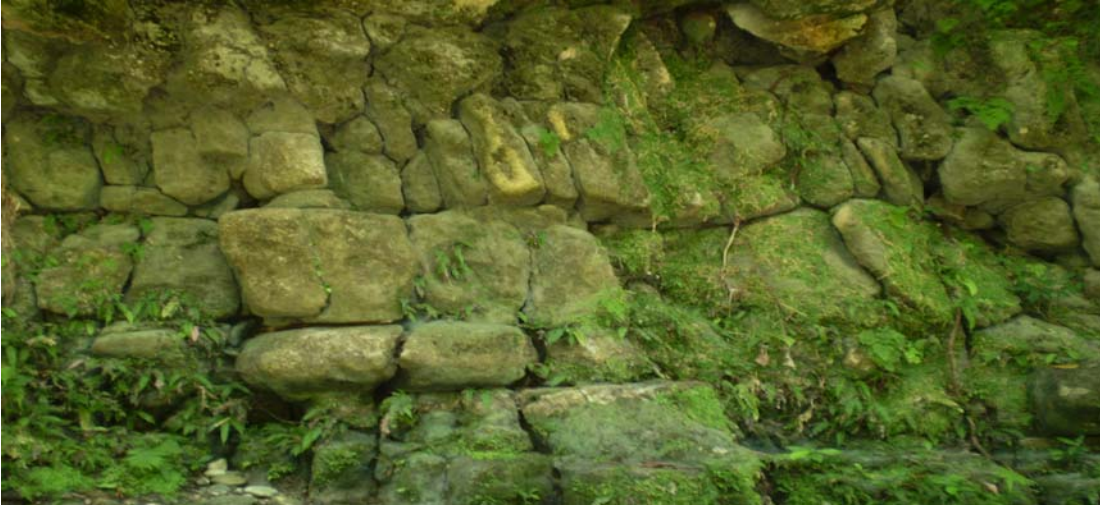
PICTURE 6 SHOWING LOOSE BLOCKS OF LIMESTONE ALONG THE JOINTS.

This is an example of one type of landslide seen on the field along the river bank known as block fall. The blocks of limestone fall off along joints into the river along the river and along road cuts. Blocks that fall into the river add to the sediments load carried along the river course. Along the roads, these blocks fall off blocking roadway and preventing transportation to and from the area.

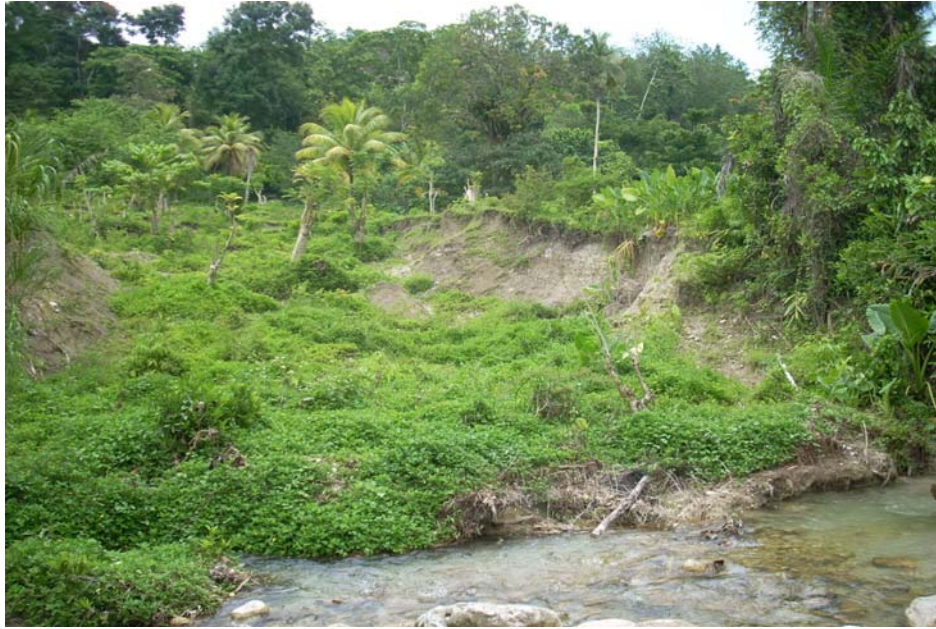
PICTURE 7 SHOWING SLUMPING

The picture above shows slumping of the land. The lack of vegetation in the slumping area results in excessive erosion when rain falls. Debris and water makes its way into the river. The limestone allows for the water to make its way through the weathered soil.

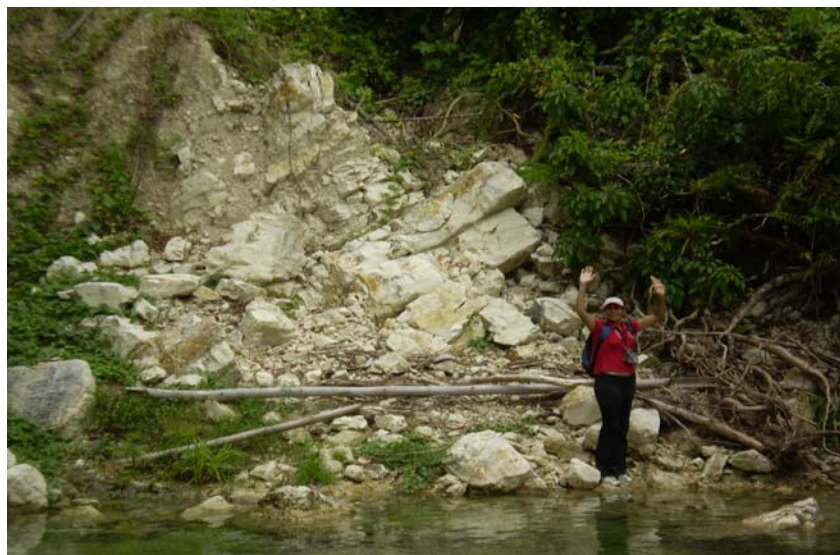
PICTURE 8 SHOWING MAJOR LANDSLIDE ALONG THE RIVER BANK

The landslip seen is mainly due to heavy precipitation and undercutting of the river bank by the moving water when river is in flood. It is also due to the movement of water through the pore spaces of the already loose soil. This results in the soil and rock becoming fluid and under gravity makes its way down slope.
