# Case Study of Two Typical Transmission Line Faults due to Ice Shedding

**Abstract**—Ice shedding is one of the main natural disasters threatening the safety of overhead electric transmission lines. It is a phenomenon that ice accretion is detached from electric conductors due to melting or mechanical loads, such as wind load or mechanical de-icing. As a result, large amplitude vibration and dramatic force variation will occur if large amounts of ice are shed, which may cause mechanical faults, including strands/conductor breakage, insulator rupture, tower crossarm deformation and even tower collapse. Electrical faults are also a consequence, such as flashovers or short circuits due to insufficient electric clearance among phase conductors, ground wires, tower members and the earth. Although the influence of ice shedding has been taken into consideration in the Chinese design code for overhead transmission lines, faults may still occur in certain specific conditions. However, it is rare to observe faults of the ultra high voltage (UHV) transmission lines induced by ice shedding due to their large phase-phase distance, phase-ground wire distance and tower size. Two typical faults

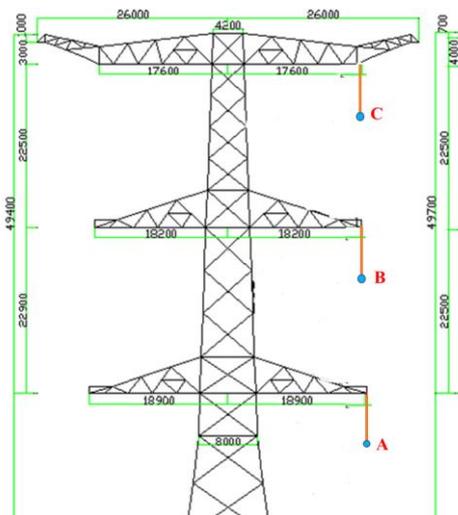
Fig. 1 Diagram of the suspension tower.

As shown in Fig. 1, the spacing between the upper and middle phase layers of the tower is 22.5 m, the spacing between the middle and lower phase layers is 22.9 m, and the height of the ground wire support is 3 m. The horizontal offset of the upper and middle phase conductors is 0.6 m, and the horizontal offset of the middle and lower phase conductors is 0.7 m.

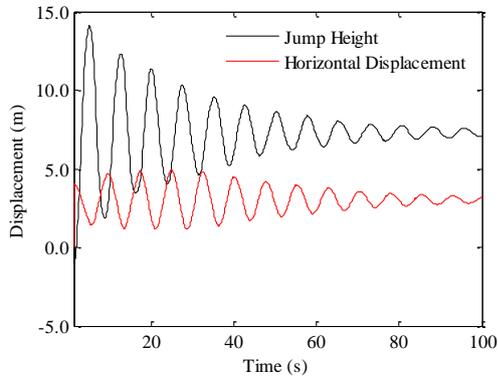
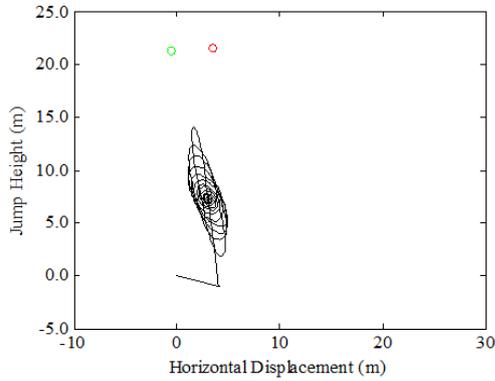
Fig. 2 Displacement of midpoint of the ice-shedding span (15 mm, 10 m/s, 80%) (a) Jump height and horizontal displacement, (b) trajectory of the midpoint and its relative position to the upper span

Fig.2 (a) and Fig.3 (a) show the time history of the jump height and horizontal displacement of the midpoint of the middle phase. Fig.2 (b) Fig.3 (b) show the trajectory of the midpoint and its relative position to the upper span, where the green circle is the initial position of the midpoint of the upper phase without wind and the red circle is the new position under wind loads. To be noted, the red mark coincides with the green one when there is no wind as in Fig. 3 (b).

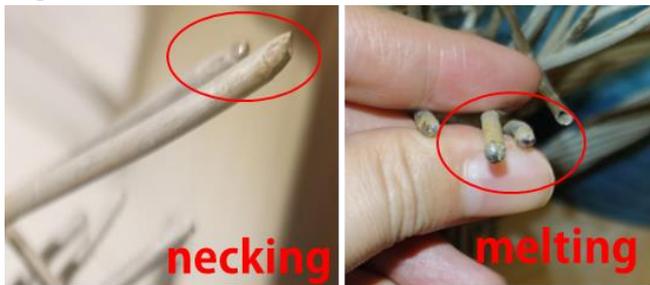
environmental temperature was about 0°C as recorded by a nearby monitoring device. According to photographs of the conductor, obvious discharge points can be seen. For the OPGW, four of the 18 strands had obvious stress tensile necking morphology, and the outer surface was smooth without high-temperature burning trace. The other 14 strands had different degrees of high-temperature overheating. Therefore, ice shedding was the most suspicious cause. Discharge occurred when the conductor jumped above towards the OPGW, and 4 strands of the OPGW were burnt at high temperature, resulting in the decrease of its strength, and then large tension caused the breakage of the remaining valid strands. Typical failure modes of the strands are shown in Fig. 4. Noted that the possibility of galloping is also excluded, because the calculation shows that galloping with the same vibration level will loosen the bolts of the towers. The inspection after the fault did not find the hints.

Fig.4 Typical failure modes of the OPGW strands

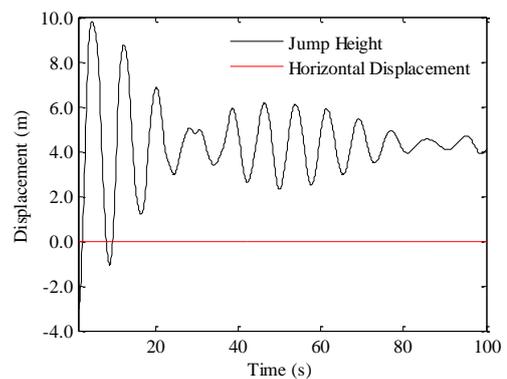
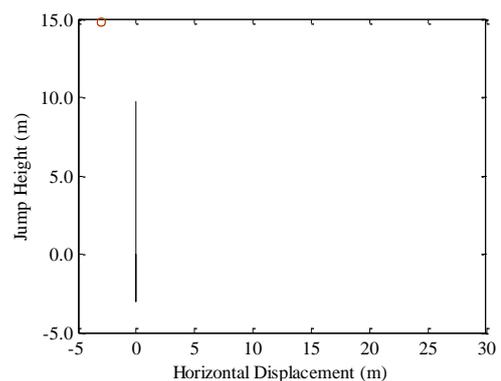
Fig.5 Displacement of midpoint of the ice shedding span (conductor ice thickness 15 mm, 0 m/s, 100%) (a) Jump height and horizontal displacement, (b) trajectory of the midpoint and its relative position to the OPGW

Fig.5 (a) and Fig.6 (a) show simulated time histories of the jump height and horizontal displacement of the midpoint of the conductor. Fig.5 (b) and Fig.6 (b) show the trajectory of the midpoint and its relative position to the OPGW, where the green circle is the initial position of the OPGW midpoint without wind and the red circle is the new position under wind loads. To be noted, the red mark coincides with the green one when there is no wind as shown in Fig. 5 (b).

The horizontal offset between the conductor and the OPGW is 3.2 m at the strain tower and 2.8 m at the suspension tower, both of which are greater than the minimum allowed electrical clearance value of 2.5 m. This means that even when the conductor jumps to the height of the OPGW in still air, discharge cannot happen. However, it is found from Table V and Figs. 5 and 6 that when the ice thickness and the ice shedding ratio exceed the design values, and there is wind acting at the same time, discharge may occur.

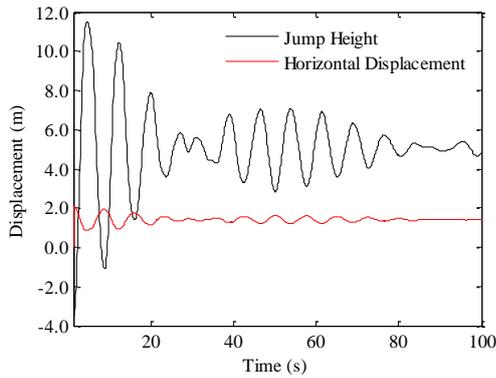
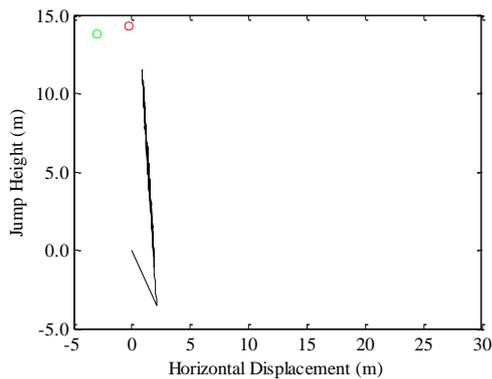
Fig.6 Displacement of midpoint of the ice shedding span (conductor ice thickness 17.5 mm, 10 m/s, 100%) (a) Jump height and horizontal displacement, (b) trajectory of the midpoint and its relative position to the OPGW

When the ice thickness is 17.5 mm, the calculated minimum dynamic clearance is 2.51 m which is close to the allowed value of 2.50 m. Wind load further exacerbates the situation because the horizontal displacements of the OPGW

and the conductor are different under the same wind speed. However, in the current design code, the unequal horizontal displacements of the OPGW and the conductor during ice shedding is not considered, which is one of the possible reasons for ice shedding-induced faults. Ice shedding-induced faults observed in transmission lines of other voltage levels also show a similar mode. Thus, in the design of transmission lines with high risk of ice shedding, it is necessary to consider the combined effects of ice and wind and more margin is needed in electrical clearances.
