Improving the Nutrition and Health of CARICOM Populations (CARICOM)

BASELINE RESULTS FOR SOIL AND WATER ANALYSIS COMPONENT IN ST. LUCIA AND ST. KITTS

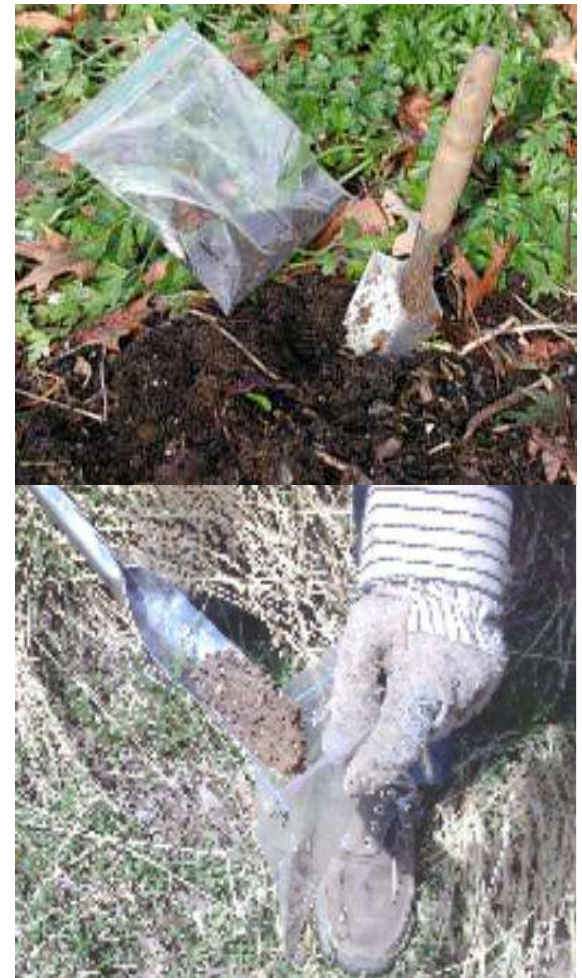
- One composite sample per plot at each depth- **chemical parameters, and particle size**
 - **STAPLETON- 8 samples- 4 at each depth**
 - **MANSION- 24 samples- 12 at each depth**
 - **BLACK BAY- 16 samples- 8 at each depth**

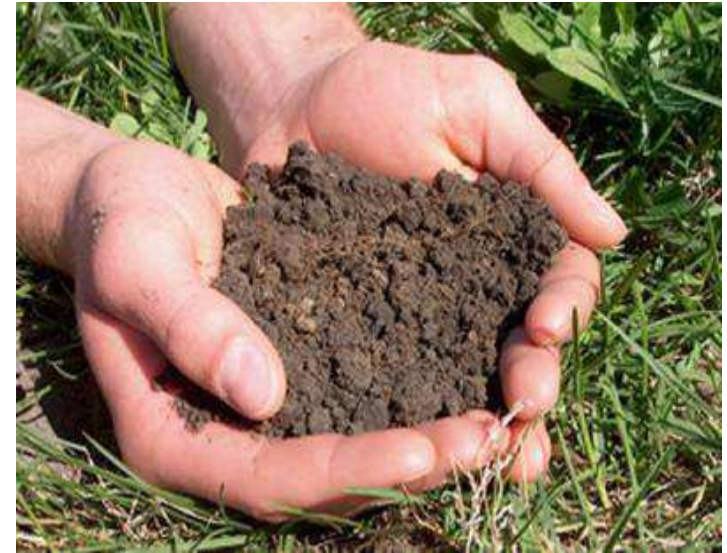
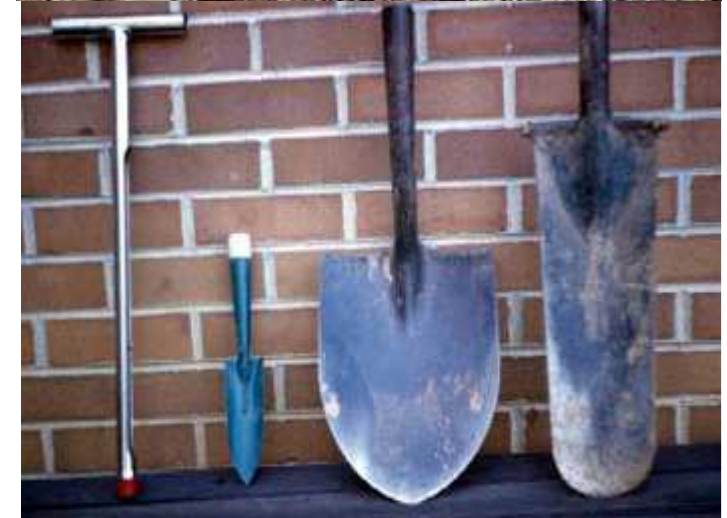
Soil sample depth

- 0-6 inches
- 7-12 inches

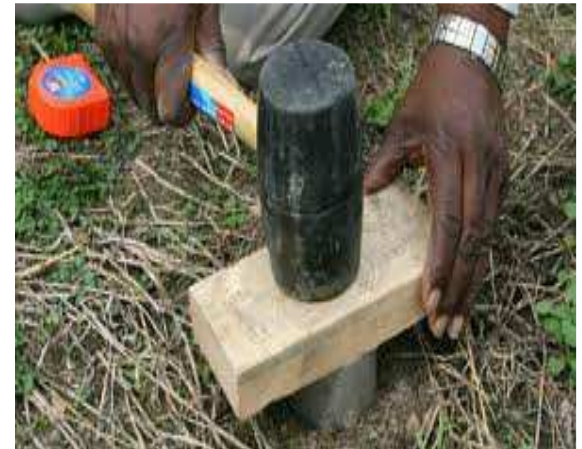
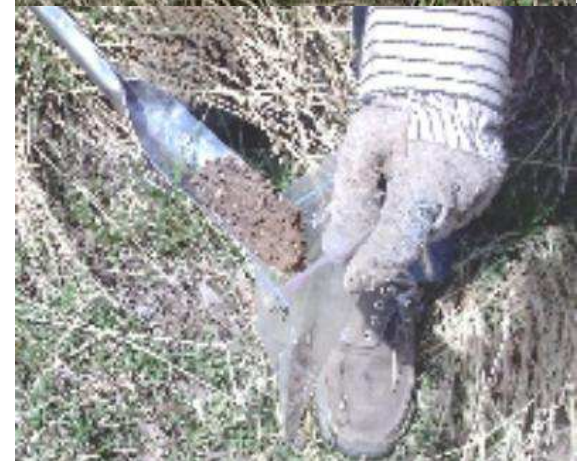
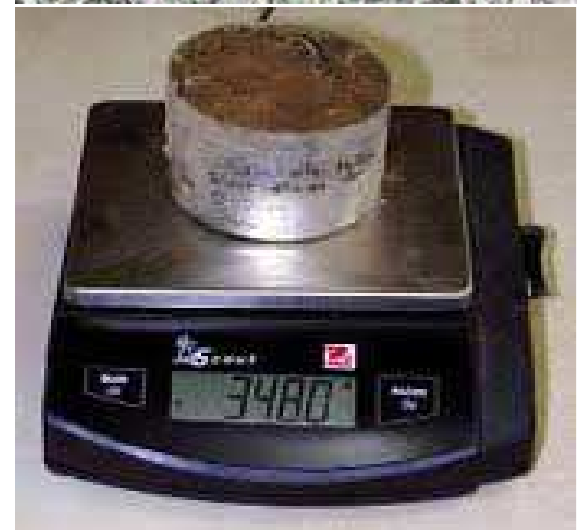
- One sample per plot at each depth- **bulk density**
 - STAPLETON- 4 samples
 - MANSION- 12 samples
 - BLACK BAY- 8 samples

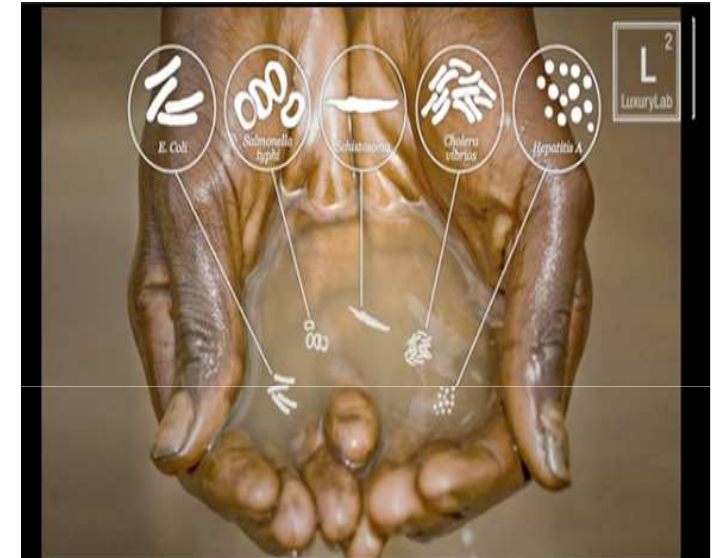
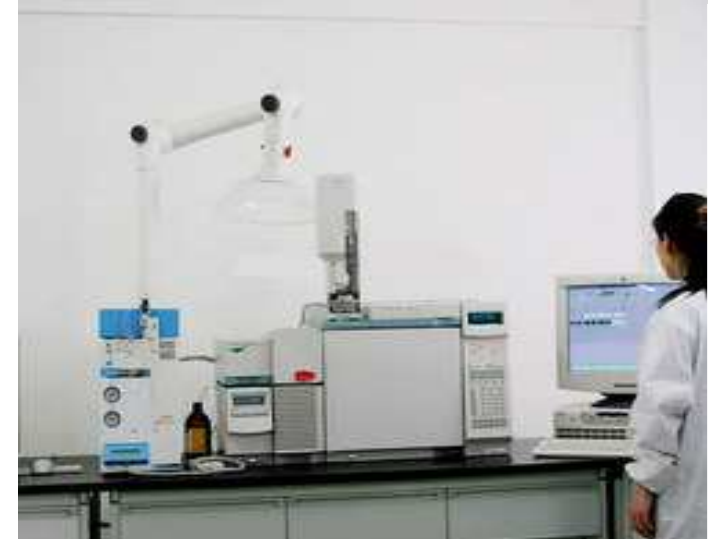
Baseline Water Sampling

- E. Coli- 5 samples in 30-day period
- Other parameters- 1 sampling occasion per season

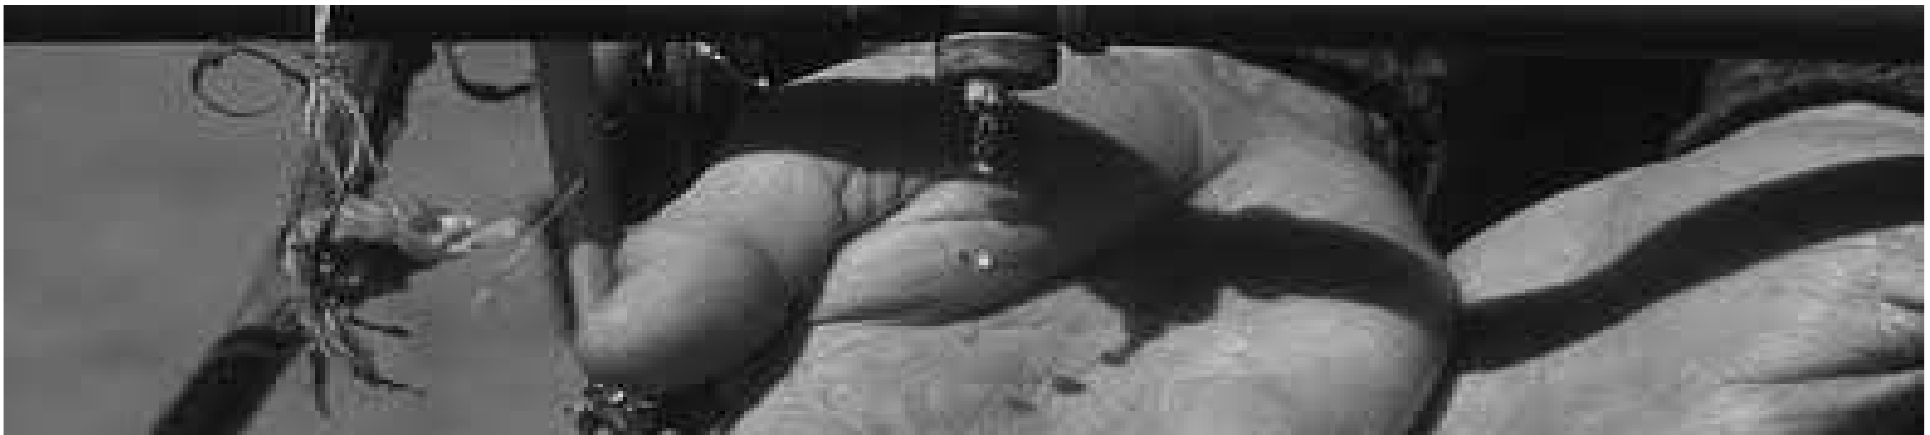
WATER QUALITY

- E. Coli count is <1 CFU/ml
- Organochlorine pesticide concentration found to be below the MDL

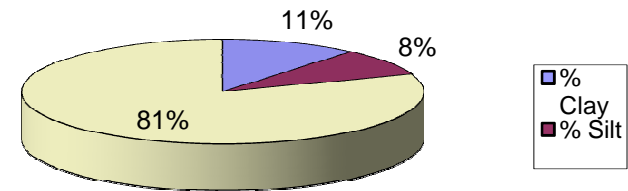
Average Particle Size Distribution for Stapleton Soil Samples taken at 0-6"

- Stapleton
 - Soil type-
 - Moderately to slightly acidic
 - Sandy loam
 - Approx 6% organic matter by weight
 - Bulk density - good for plant growth, does not inhibit root growth

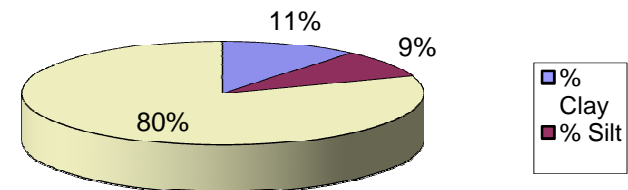
Average Particle Size Distribution for Stapleton Soil Samples taken at 7-12"

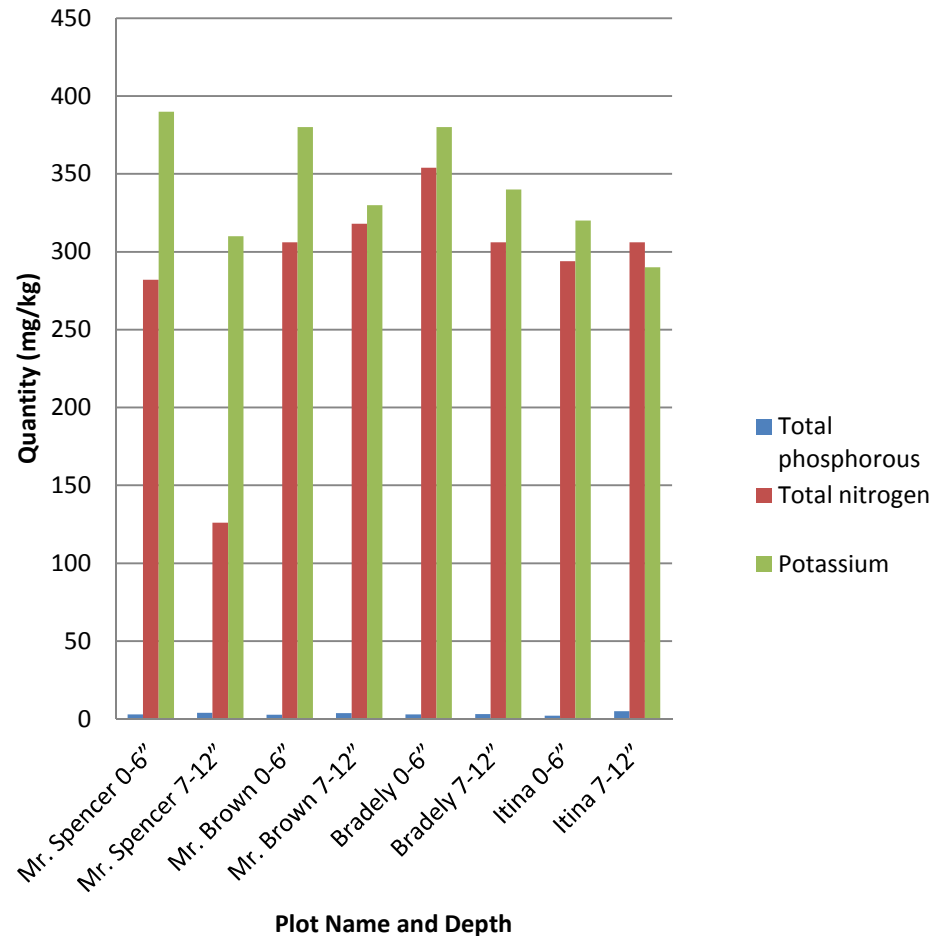
Essential Nutrients in Soil at Stapleton Farm Plots

- **Nitrogen**- total nitrogen analysis was performed- this test is **inconclusive** as not all total nitrogen is available for plant uptake- **recommend nitrate-nitrogen analysis for future testing.**
- **Phosphorous**- average phosphorous level = 3 mg/kg- **this is low**
- **Potassium**- average K level = 300 mg/kg- this is **medium to high**

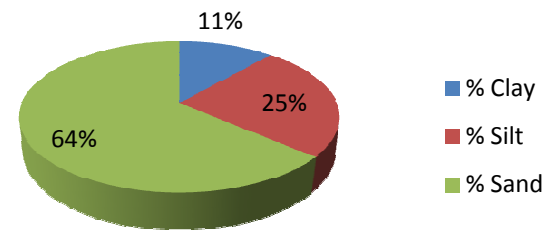
Average Particle Size Distribution for soil samples taken at 0-6" at Mansion

- Mansion
 - Soil type-
 - moderately to strongly acidic
 - Loamy sand
 - Approx 7% organic matter by weight
 - Bulk density- good for plant growth, does not inhibit root growth

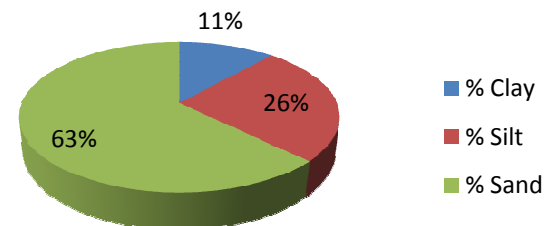
Average Particle Size Distribution for soil samples taken at 7-12" at Mansion

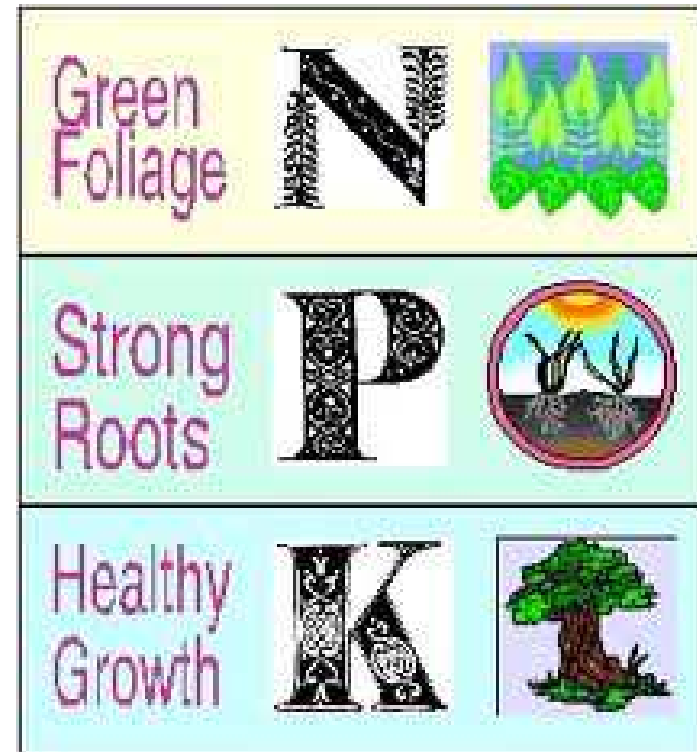
- **Nitrogen**- total nitrogen analysis was performed- this test is **inconclusive** as not all total nitrogen is available for plant uptake- **recommend nitrate-nitrogen analysis for future testing**
- **Phosphorous**- average phosphorous level = 2 mg/kg- **this is low**
- **Potassium**- average K level = 450 mg/kg- this is **medium to high**

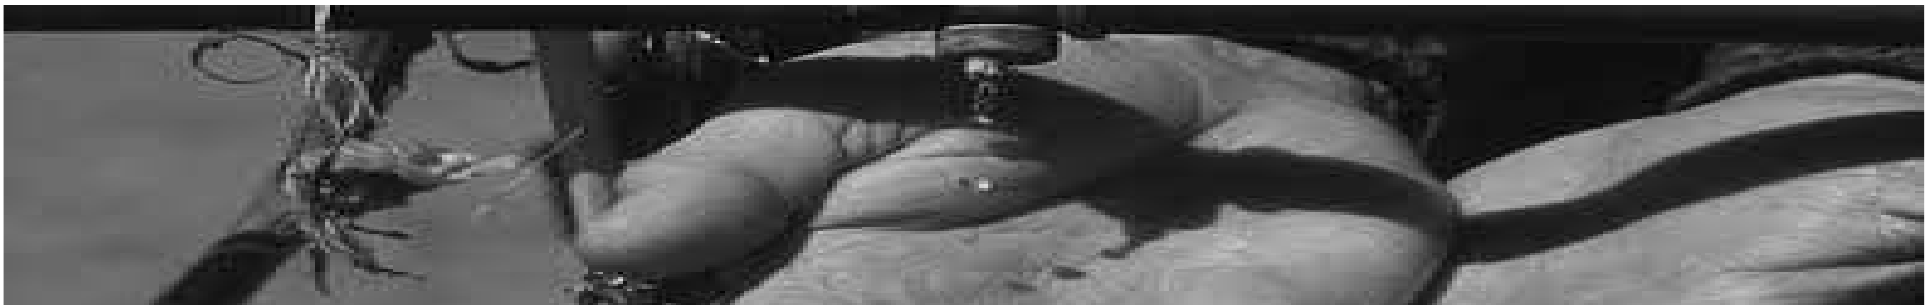
- E. coli- both upstream and downstream samples far exceeded acceptable limit for contact.

Upstream samples E. Coli Count (CFU/mL)	Downstream samples E. Coli Count (CFU/mL)
	4700	3600
	4300	3700
	2000	26
	630	970
	58	26
GEOMETRIC MEAN	404	953
