**INTERNAL AUDIT
FINAL REPORT
OF THE
MACDONALD
CAMPUS
ASBESTOS
INVESTIGATION**

MR23-03

September 14, 2023

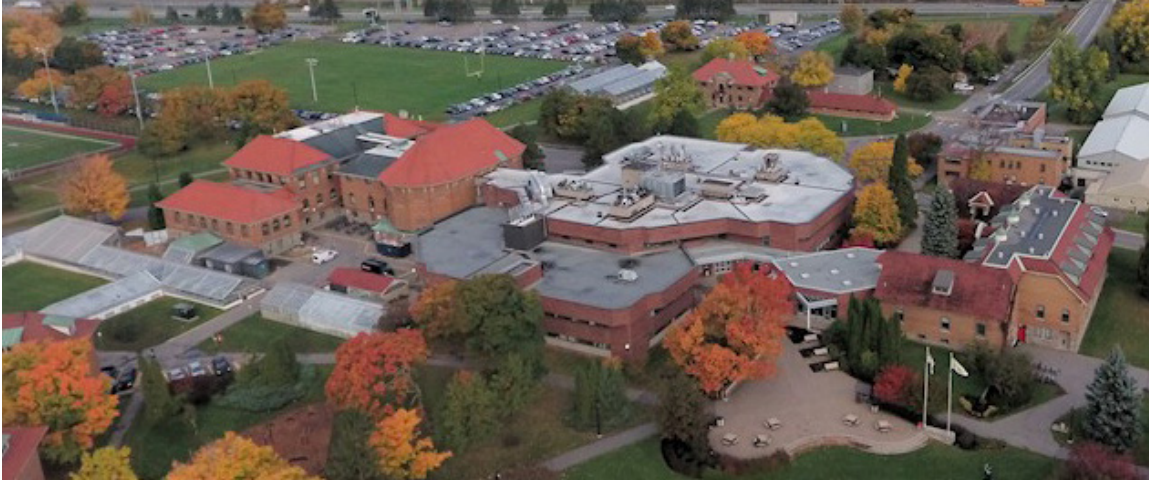
The Macdonald-Stewart (MS) Complex consists of three interconnected buildings, namely the Raymond, the MS and the Barton.

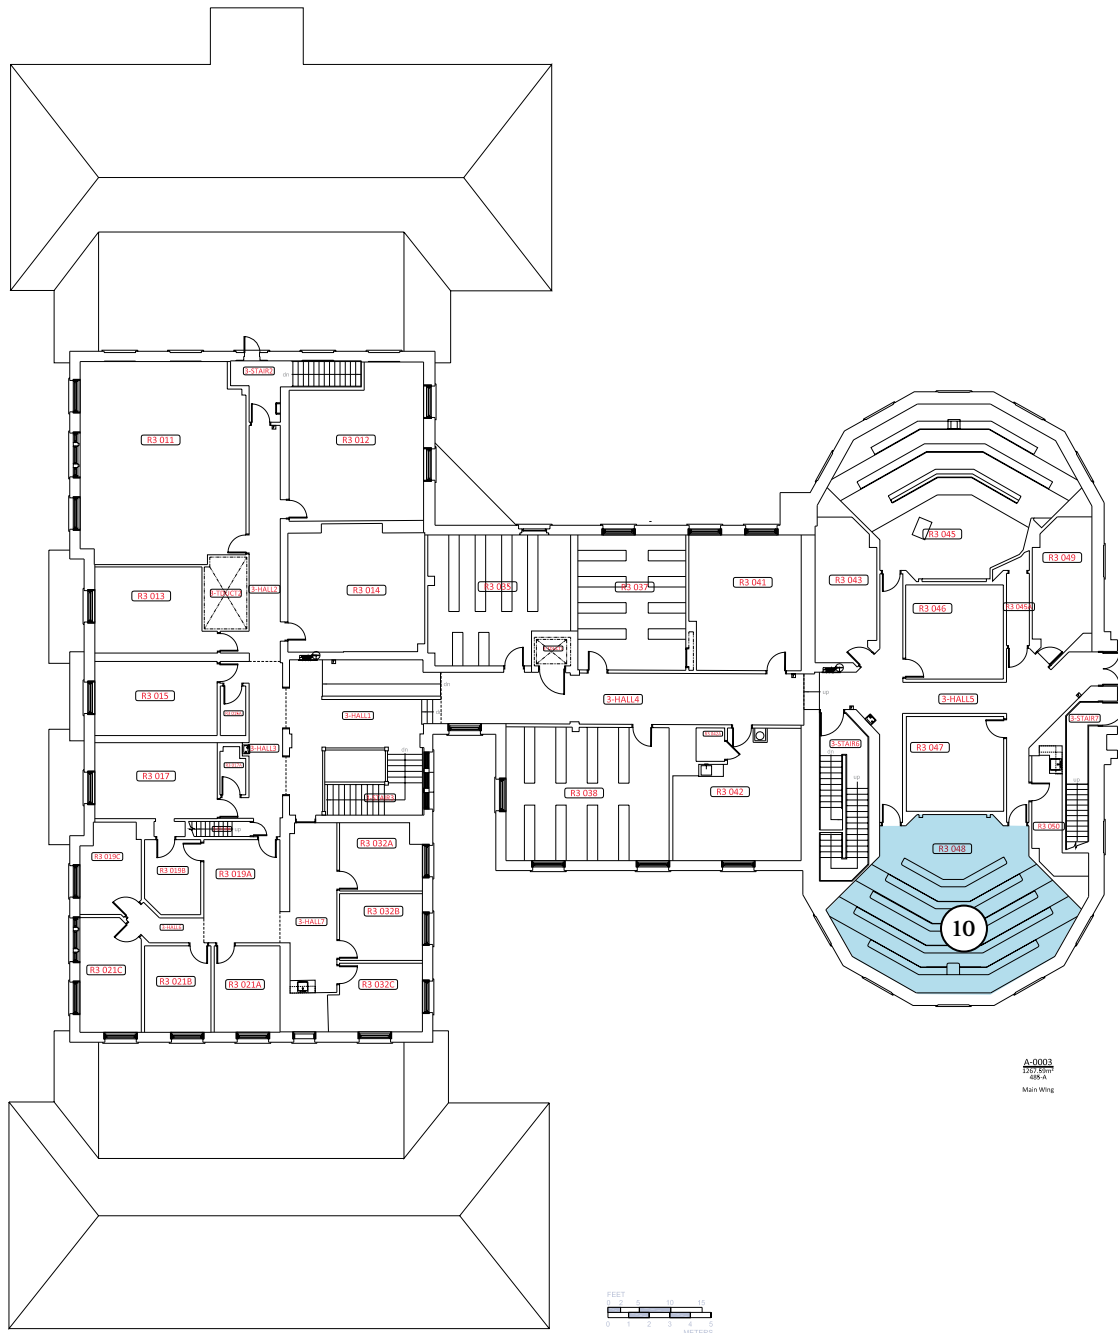
RAYMOND BUILDING – LEVEL 3

10/ R3-048

- **January 19, 2023:**
Bulk sample and wipe sample taken from R3-048. Bulk sample tests positive; wipe sample tests negative.

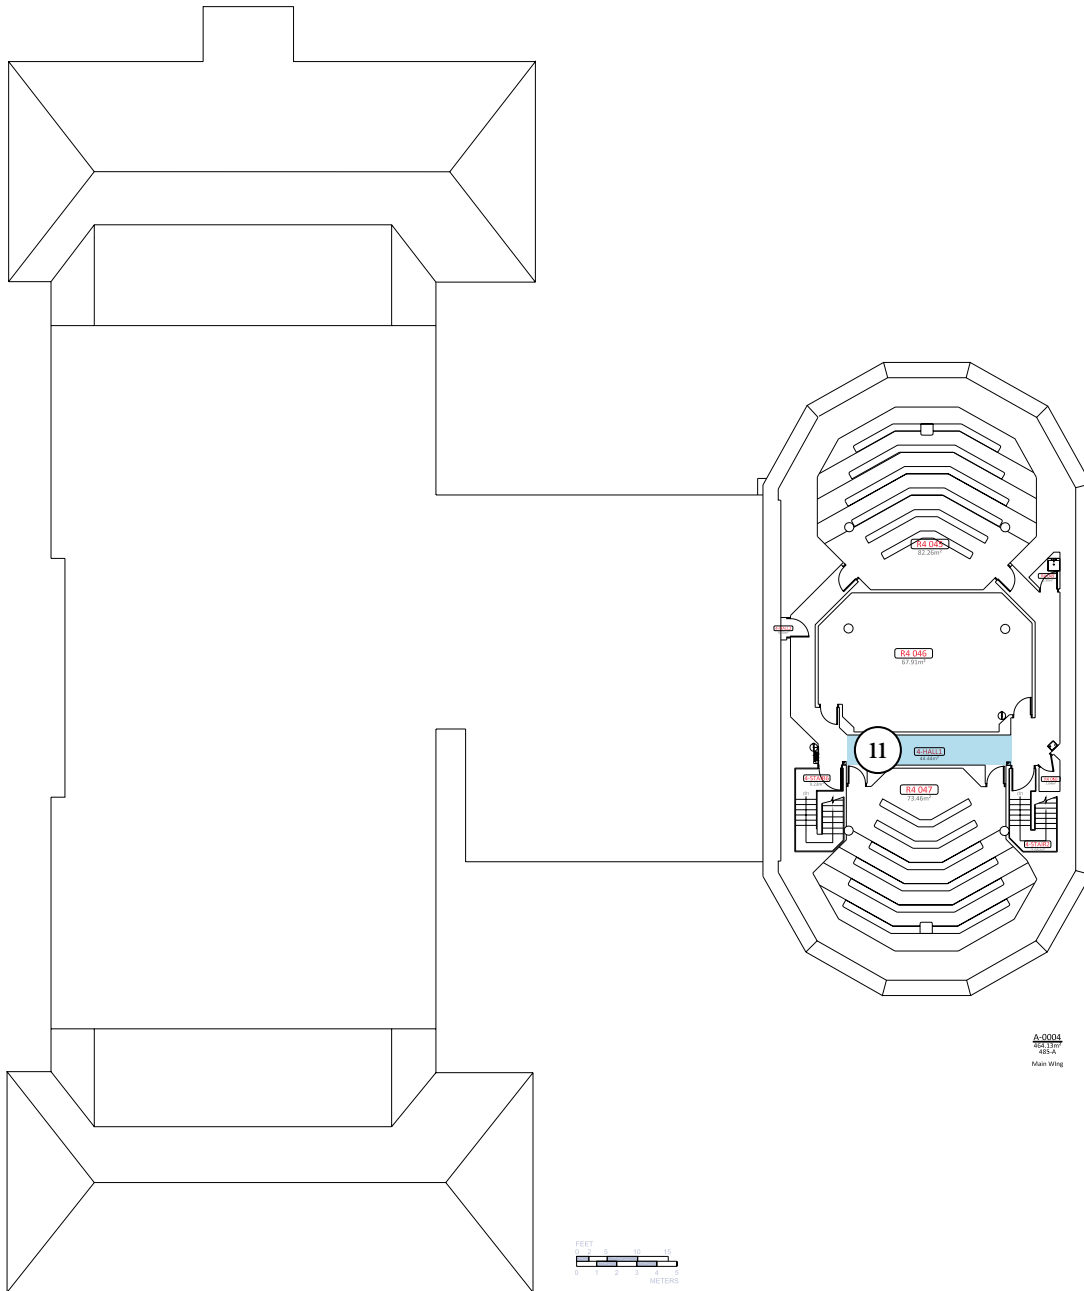
RAYMOND BUILDING – LEVEL 4

11/ R4-HALL1

- **January 19, 2023:**
Bulk sample taken from R4-Hall1; tests positive.

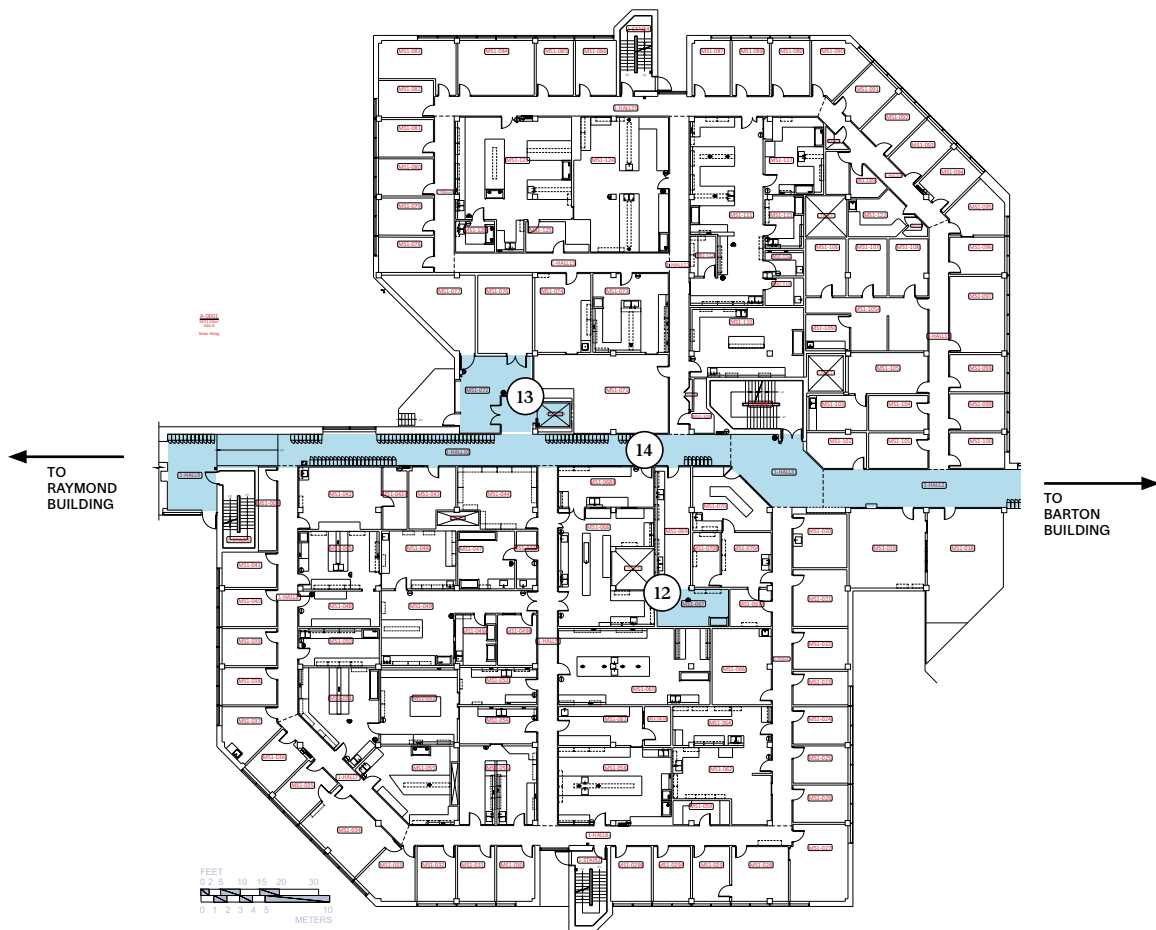
MACDONALD-STEWART BUILDING – LEVEL 1

12/ MS1-067

- **August 25, 2022:**
BSC moved from R1-029 to this location during construction without being decontaminated.
- **January 26, 2023:**
EHS took bulk sample from debris on top of the BSC; tests positive.
- **February 3, 2023:**
Industrial hygiene consultants took sample from debris on top of the BSC; tests negative.

EHS was only notified of the move on January 16, 2023 when the HEPA filter certification company could not find the BSC in the Raymond for its annual certification. On January 24, 2023, the HEPA filter certification company notified EHS that it could not certify the BSC due to debris found on top of the BSC. It is not possible to know if the BSC was properly protected during construction, or if the debris came from an earlier project.

Following the activation of the EOC and the closure of the three buildings, EOC asked the industrial hygiene consultants to test the debris found on top of the BSC on February 3, 2023. On February 7, 2023, the test results were received and indicated that the material was negative for asbestos. No conclusion has been reached on the difference in the test results from the samples taken by EHS and the samples taken by the industrial hygiene consultants.
